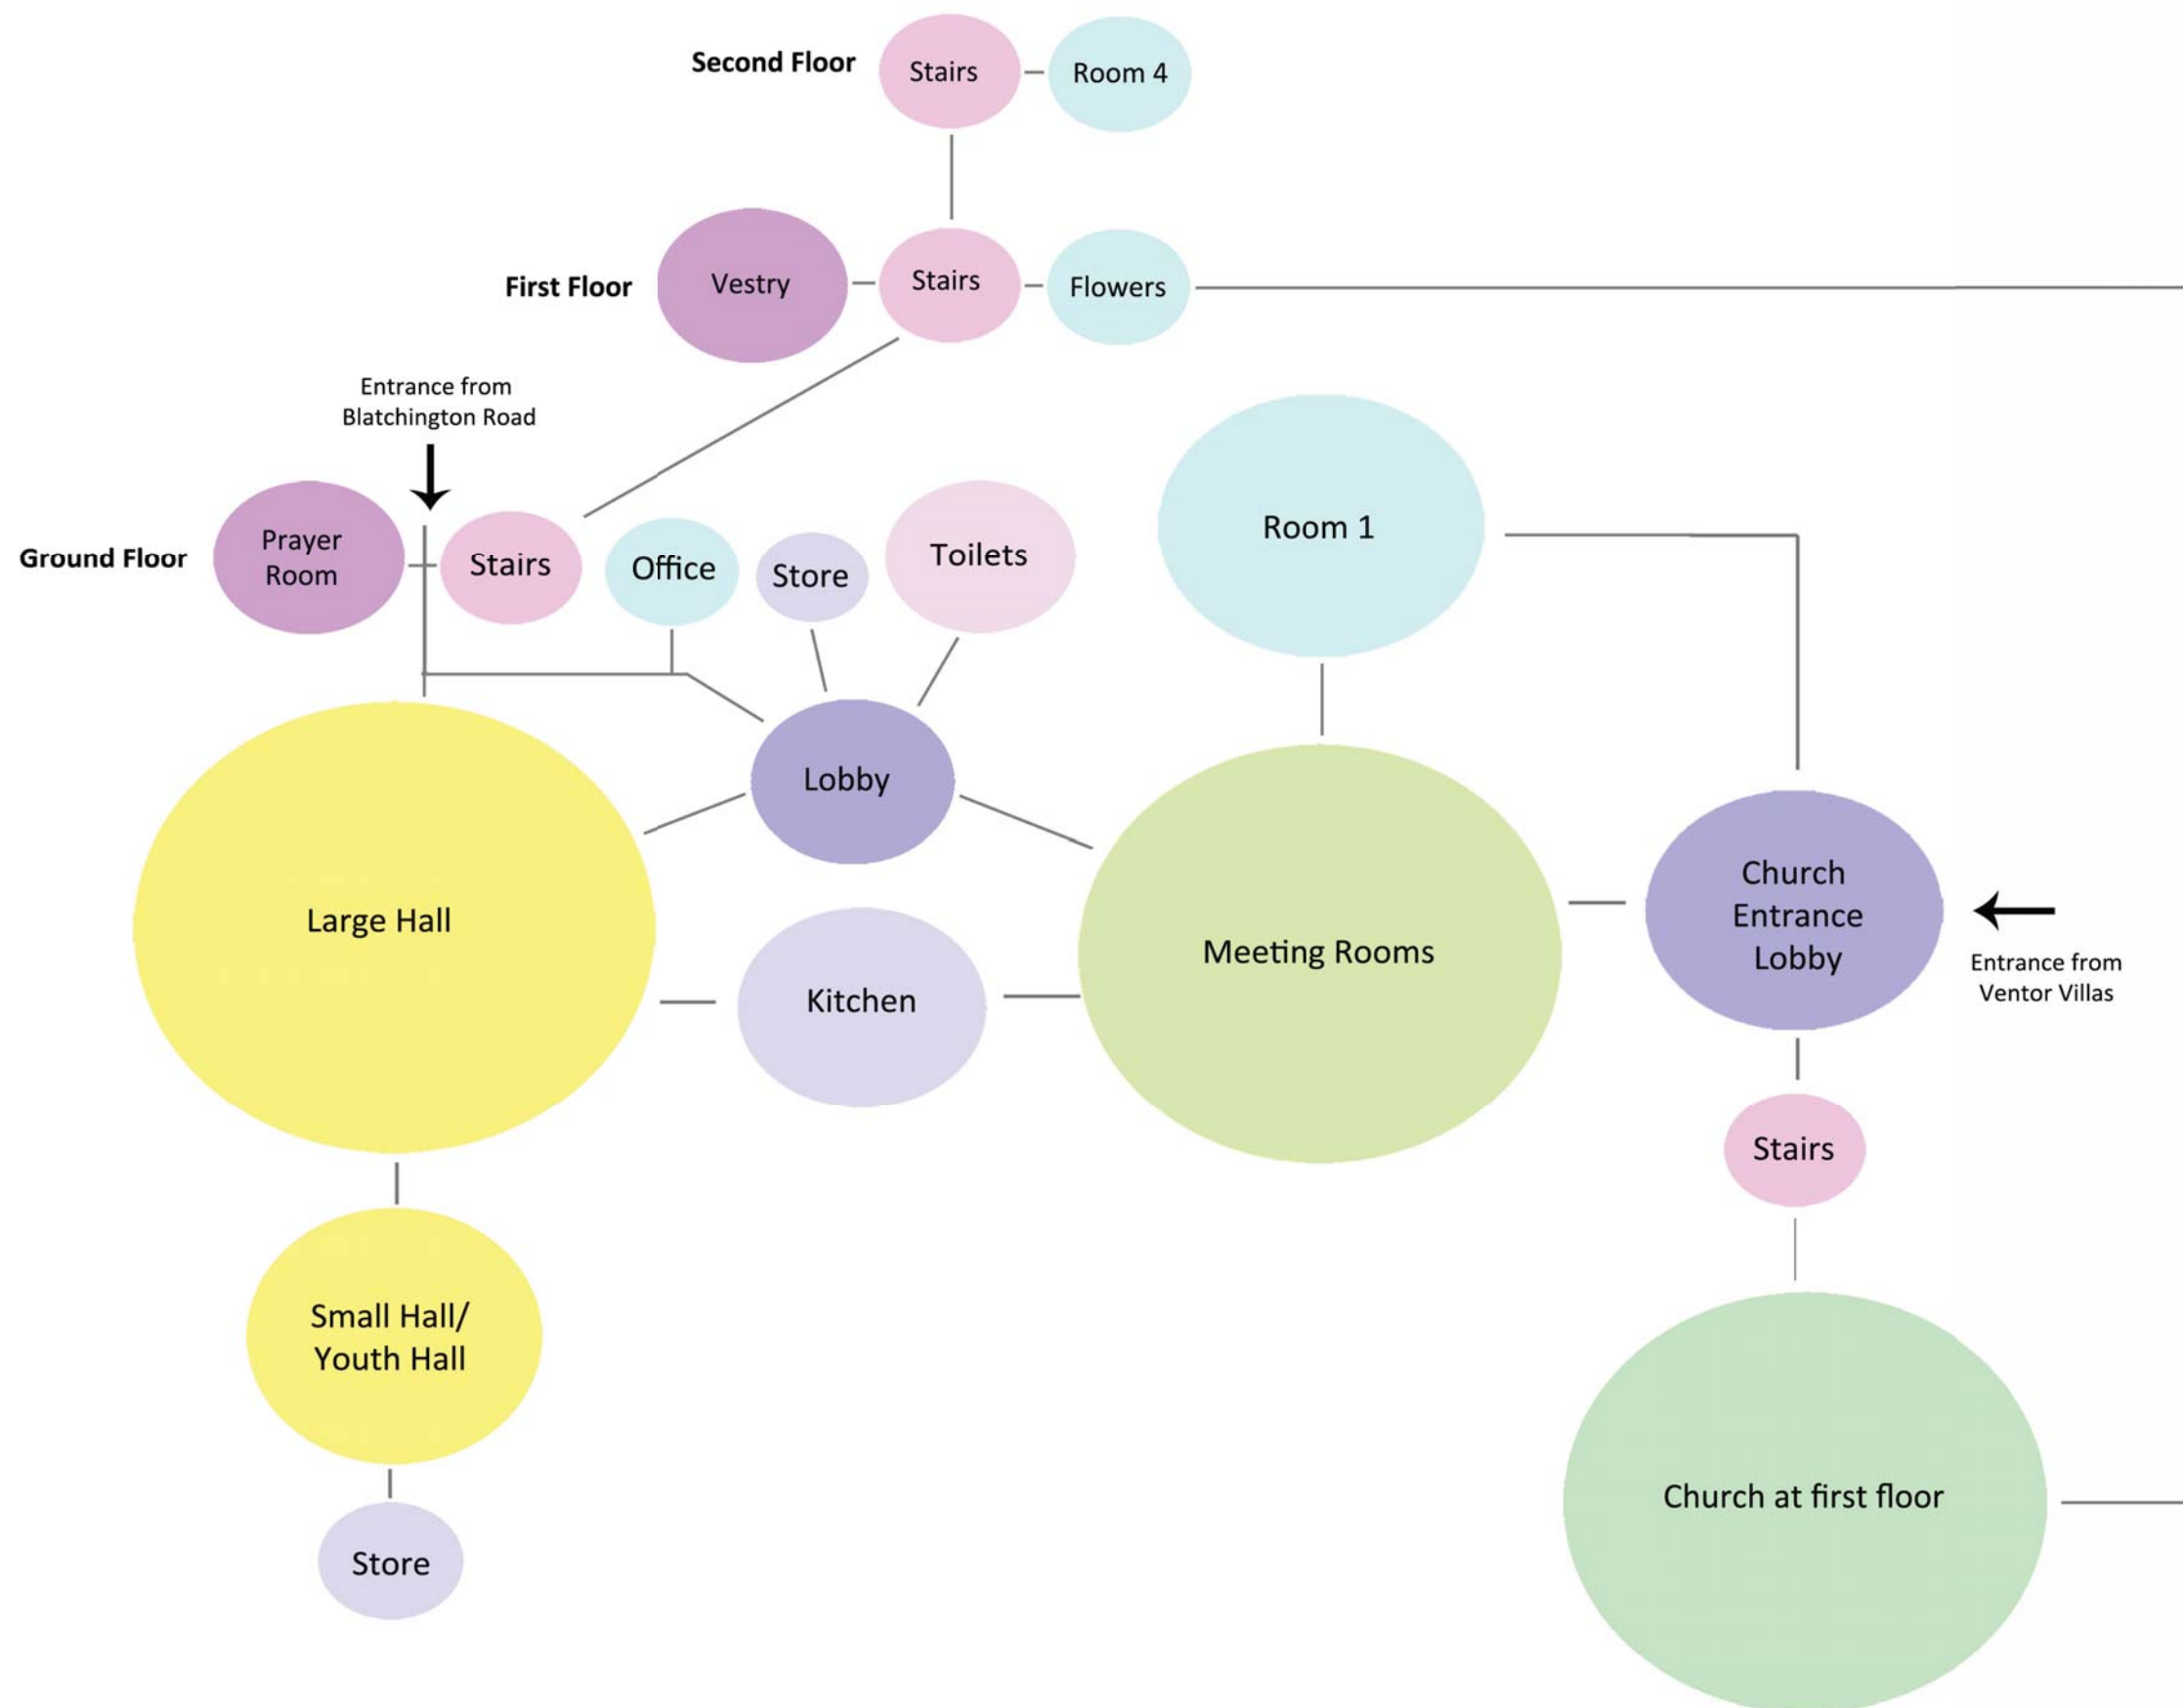
Existing Circulation:

- The existing arrangement is not ideal and makes circulation difficult around the church and centre.
- We note that the existing building does not have a heart/hub where people can meet and move between rooms.
- On Sunday the church entrance lobby is the main entrance but this is shut most of the week and the entrance from Blatchington Road is often used.

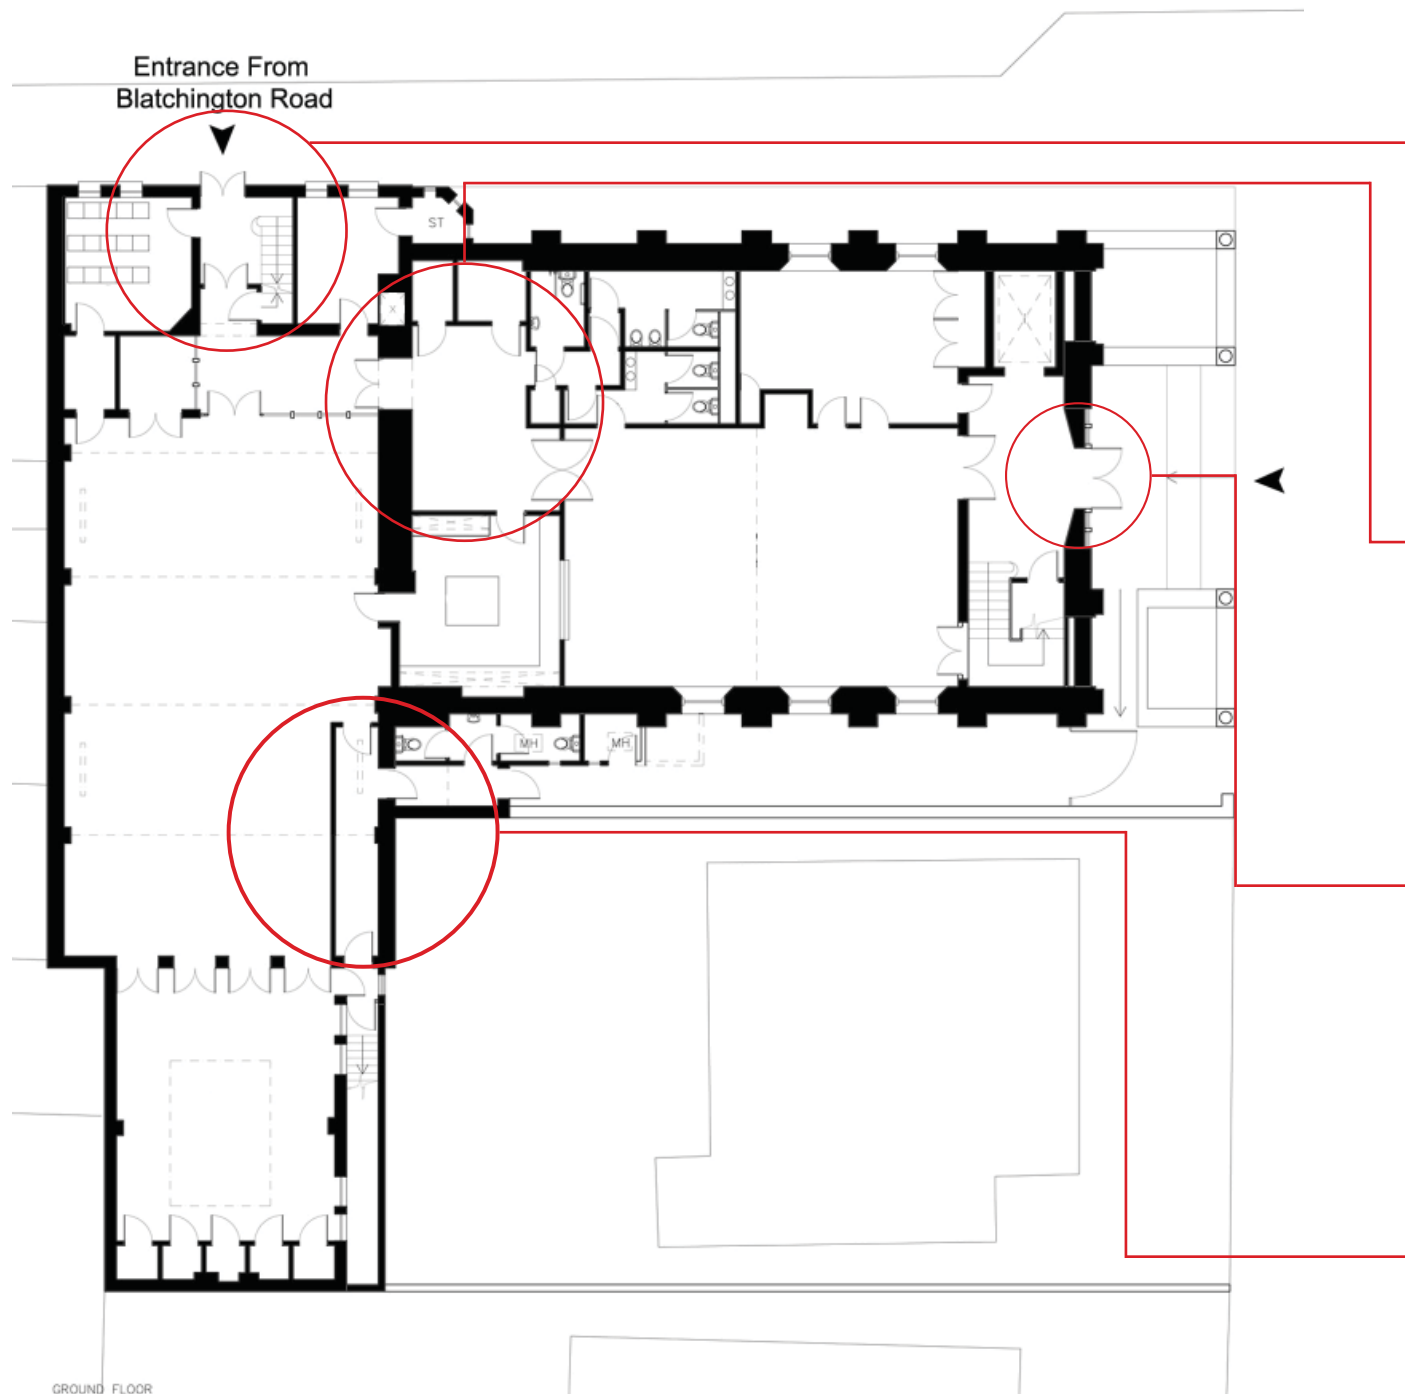
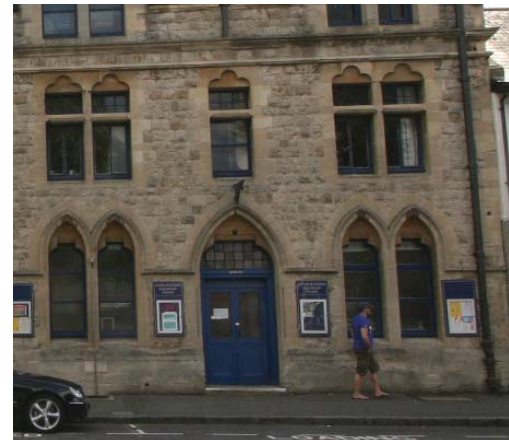
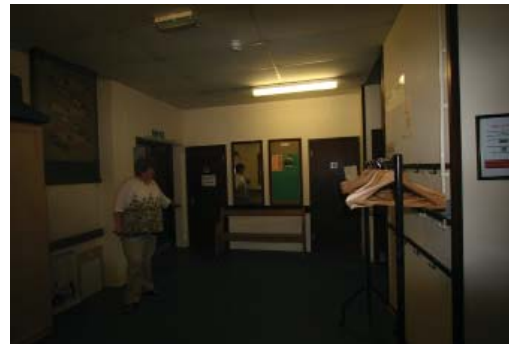
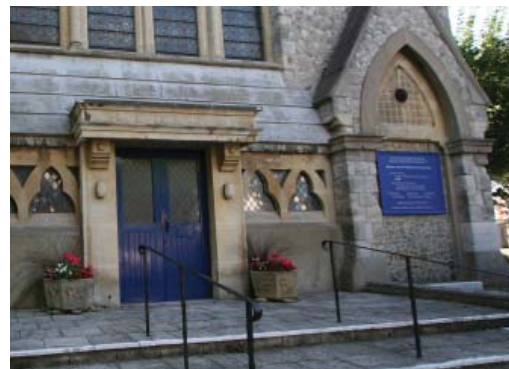
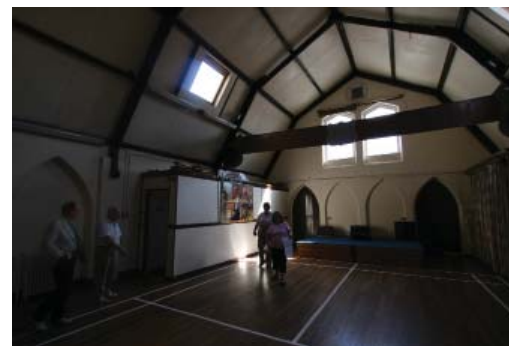
Existing Problems, Ground Floor:

- No sense of arrival or main point of entry
- The existing entrance into the church directly off Blatchington Road is understated and does not provide a sense of arrival when entering the building at this point. Due to a number of different entry points into the building it is unclear as to which one is the main entrance.
- The church is often full of activity but this is not obvious to passers by at present as there is no focal point for the public.
- The church currently does not have a “Hub” zone - ie the building lacks a central meeting point which provides easy access to all areas of the church and as a focus for the fellowship and greeting.
- The doorway accessing the church entrance lobby off Ventor Villas is not inviting.
- The corridor cuts down space in the hall and serves little function except as a ladder store.

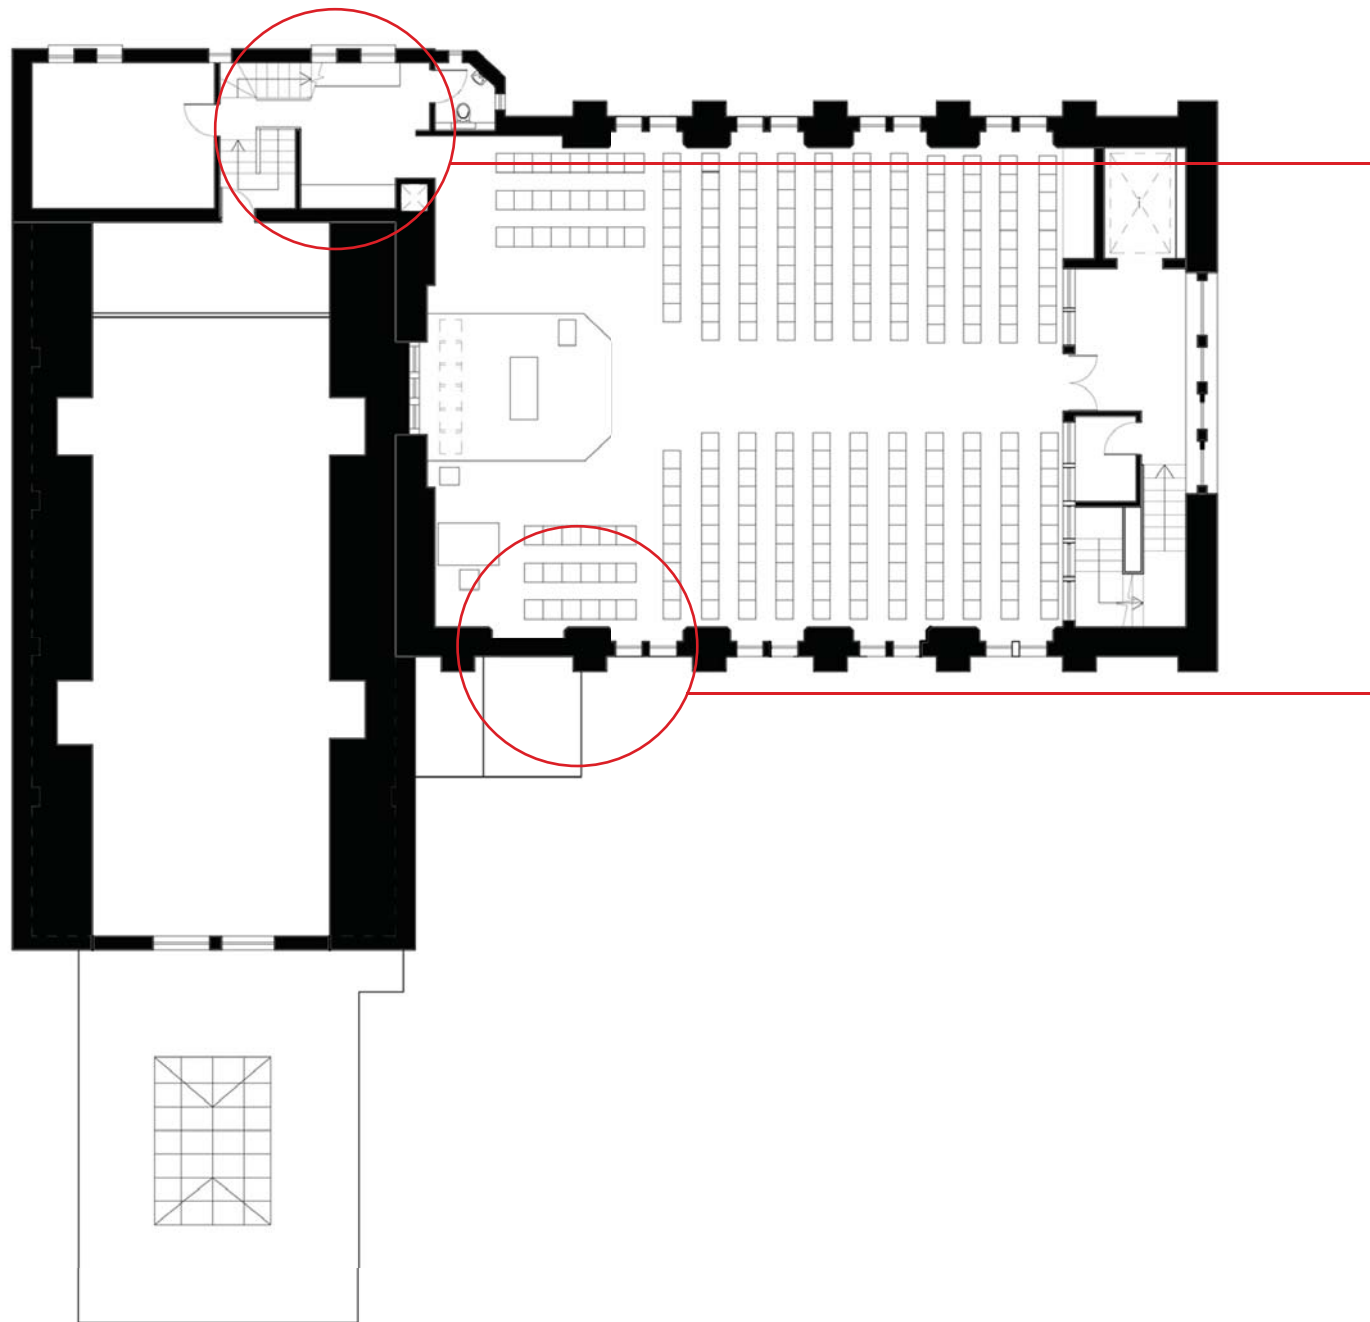
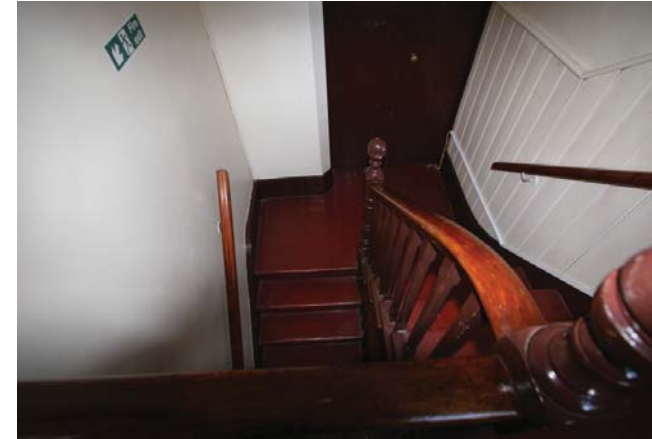
Existing Problems, First Floor:

- The current fire detection and signage needs to be upgraded and reassessed. These improvements would allow the church to use Room 4 at second floor level. This room is currently unused due to no fire detection and means of escape.

1. New smoke detectors and emergency lighting is installed.
2. Roof to new main entrance at ground Level
3. A new external door opening and fire escape stair is provided to allow for adequate means of escape. Emergency lighting is to be installed above the fire escape door.

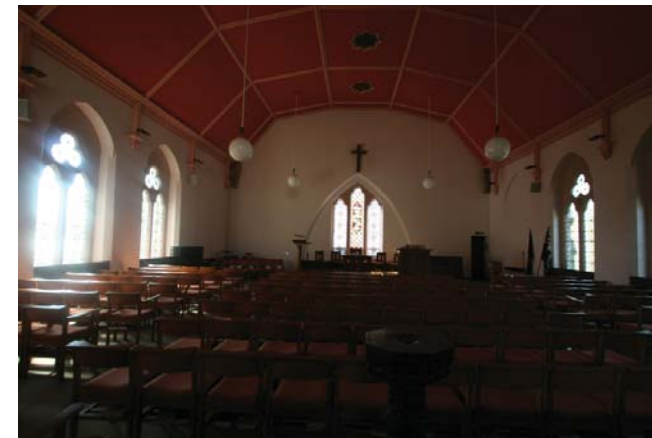
- We note that the existing means of escape during a fire emergency is poor and needs to be addressed at first floor level.

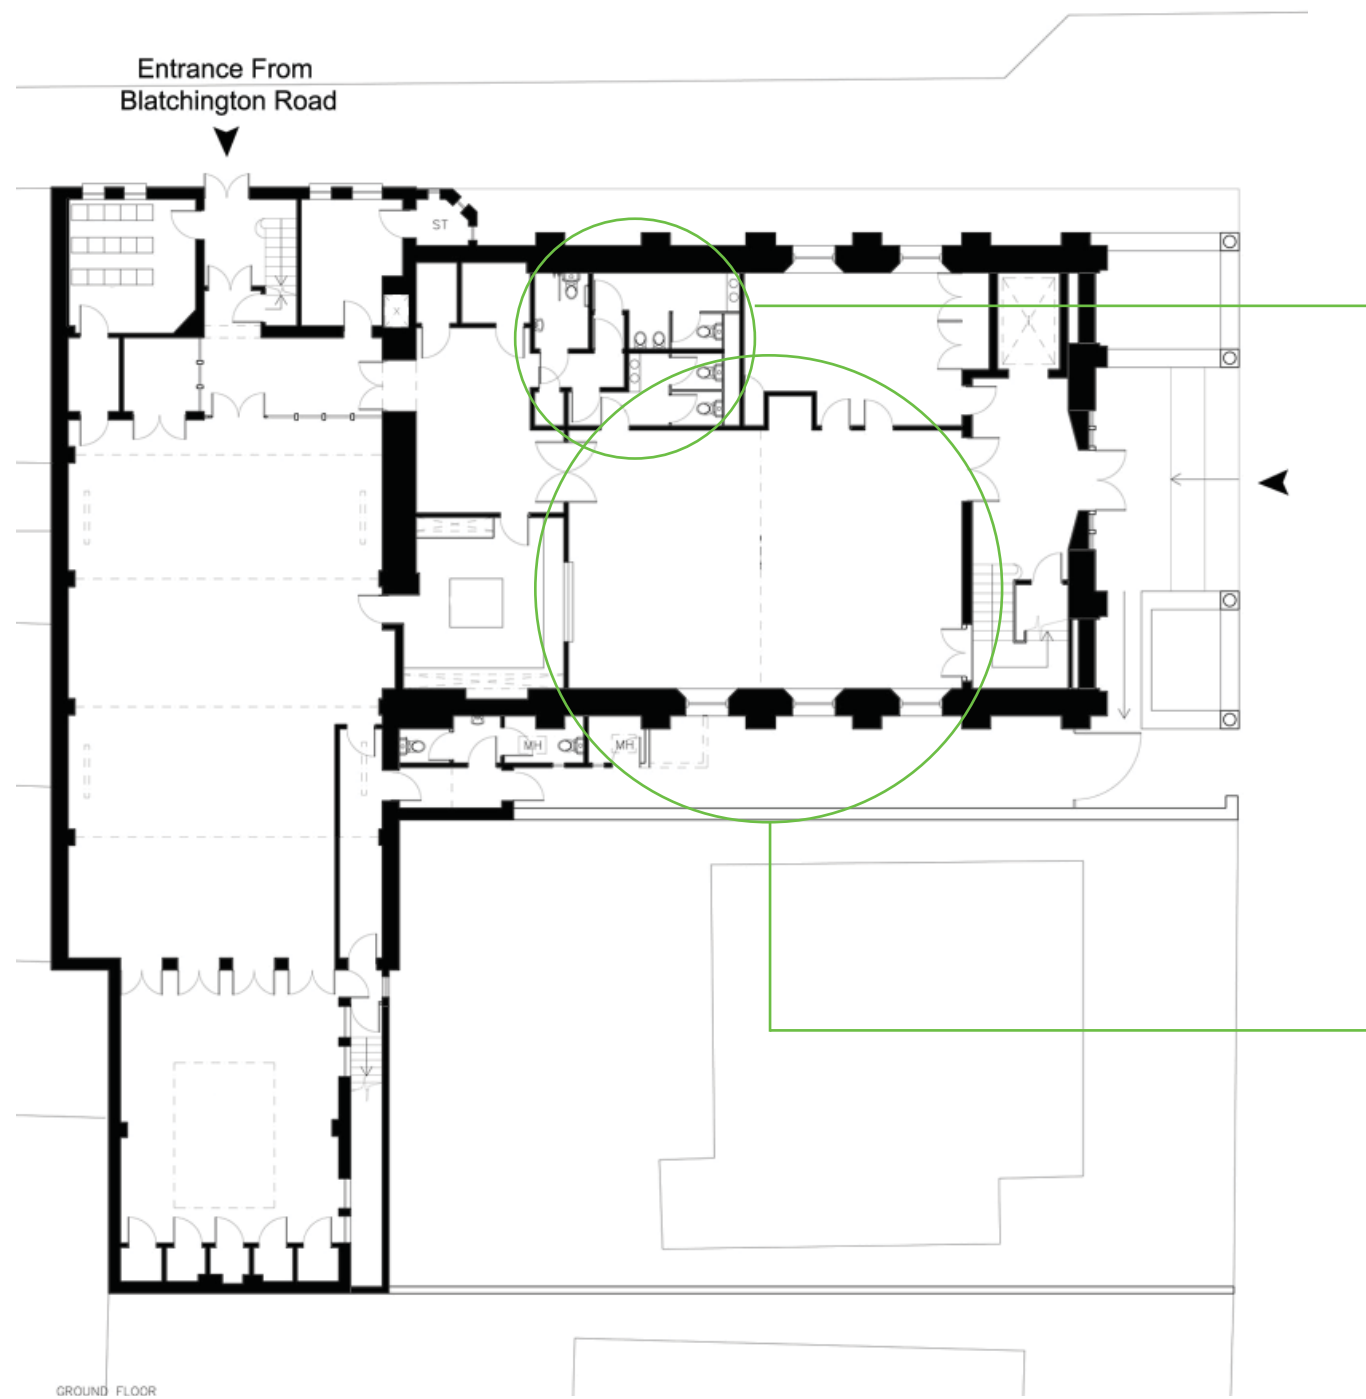
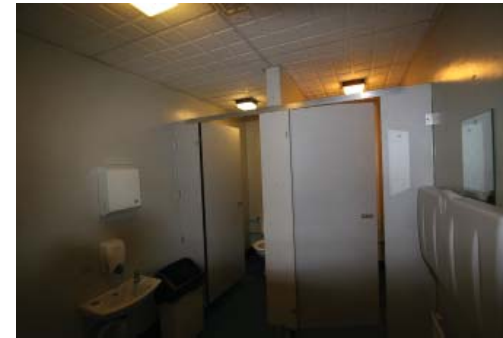
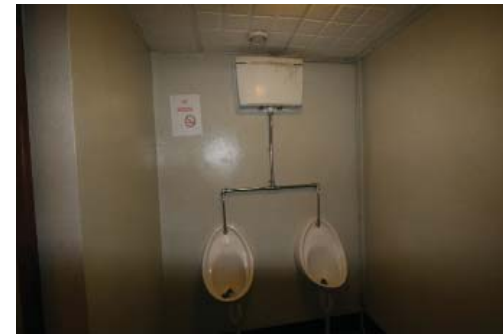
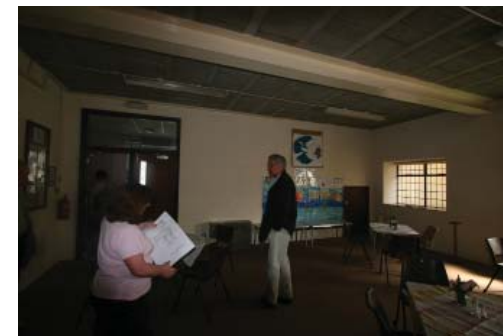
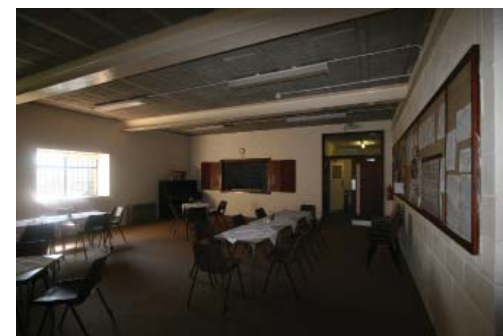
Proposed Improvements:

- The toilets would benefit from being refurbished. The existing facilities are dark and unwelcoming.
- The existing DWC is currently too small and does not comply with building regulations. We propose to enlarge the DWC by moving one of the internal walls and removing the existing store which is opposite to provide a turning circle and easy access.

- The existing ceiling in the meeting room and committee room at ground floor level is the beam and block construction of the church floor at first floor level. We propose to install a suspended ceiling in both rooms which will provide the rooms with better lighting and acoustics. This will enable the rooms to be let out to the public for functions.
